Report: Chilt/IF12003 Revision A

A horizontally orientated ad-hoc fire resistance test performed on 2No intumescent air transfer grills installed within an ablative coated rock mineral fibre fire barrier

Test conducted to the temperature and pressure conditions of BSEN 1363-1: 1999 and using the methodology in draft EGOLF agreement EAXXX: 2011 – fire resistance test of air transfer grills

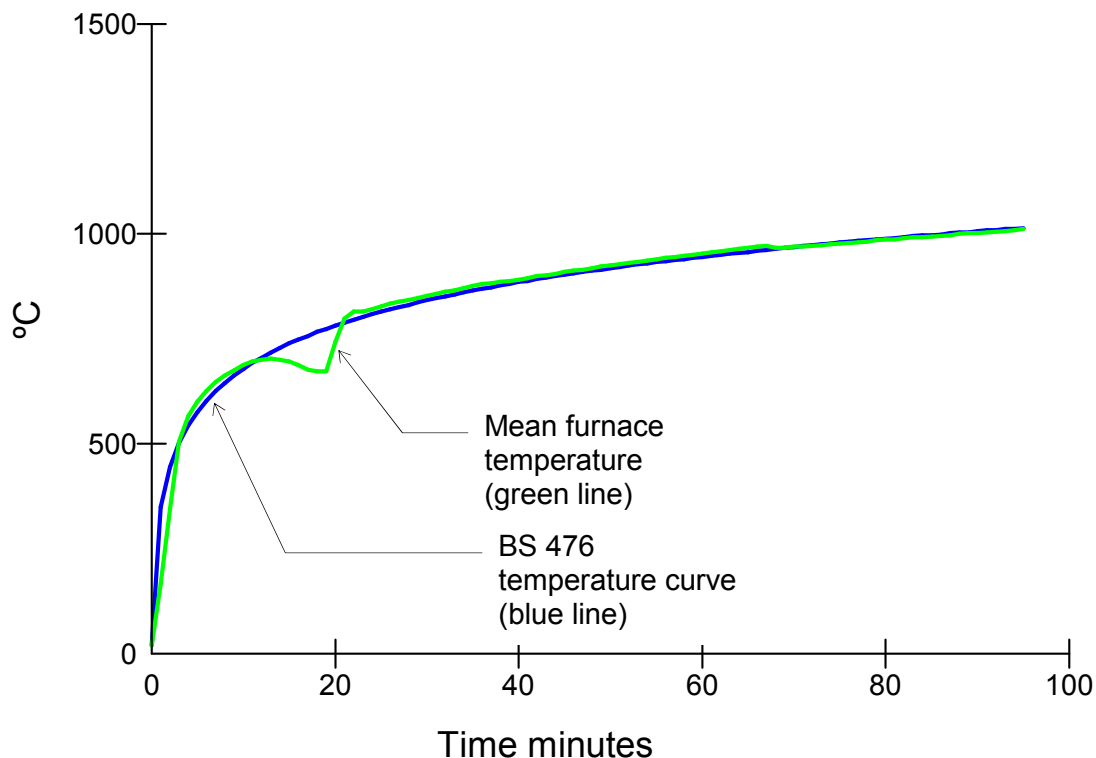
The furnace was controlled to follow the temperature/time relationship specified in BS 476: Part 22: 1987, as closely as possible, using the average of four thermocouples suitably distributed within the furnace. The furnace temperatures for the duration of the test are shown graphically below:

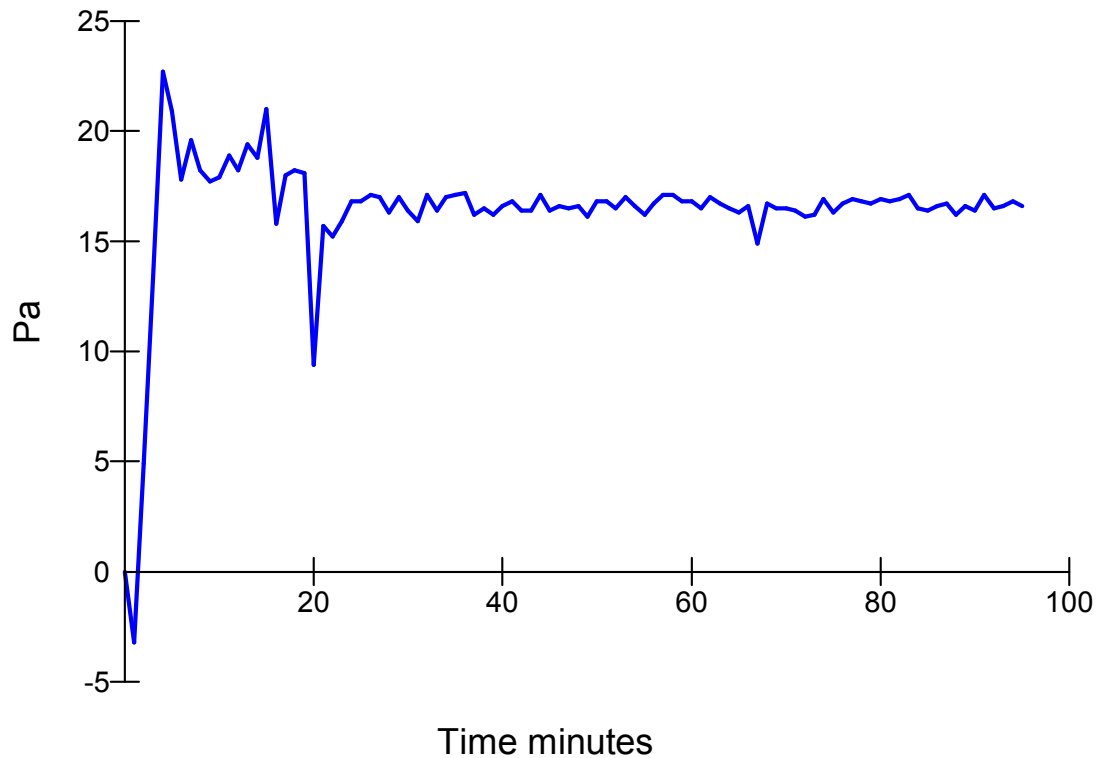
After the first 5 minutes of the test, the furnace pressure was maintained at 16.5 ± 5 Pa and after 10 minutes was maintained at 16.5 ± 3 Pa with respect to atmosphere, equating to 20Pa at the bottom of the bottom vents. The pressure readings are shown graphically below:

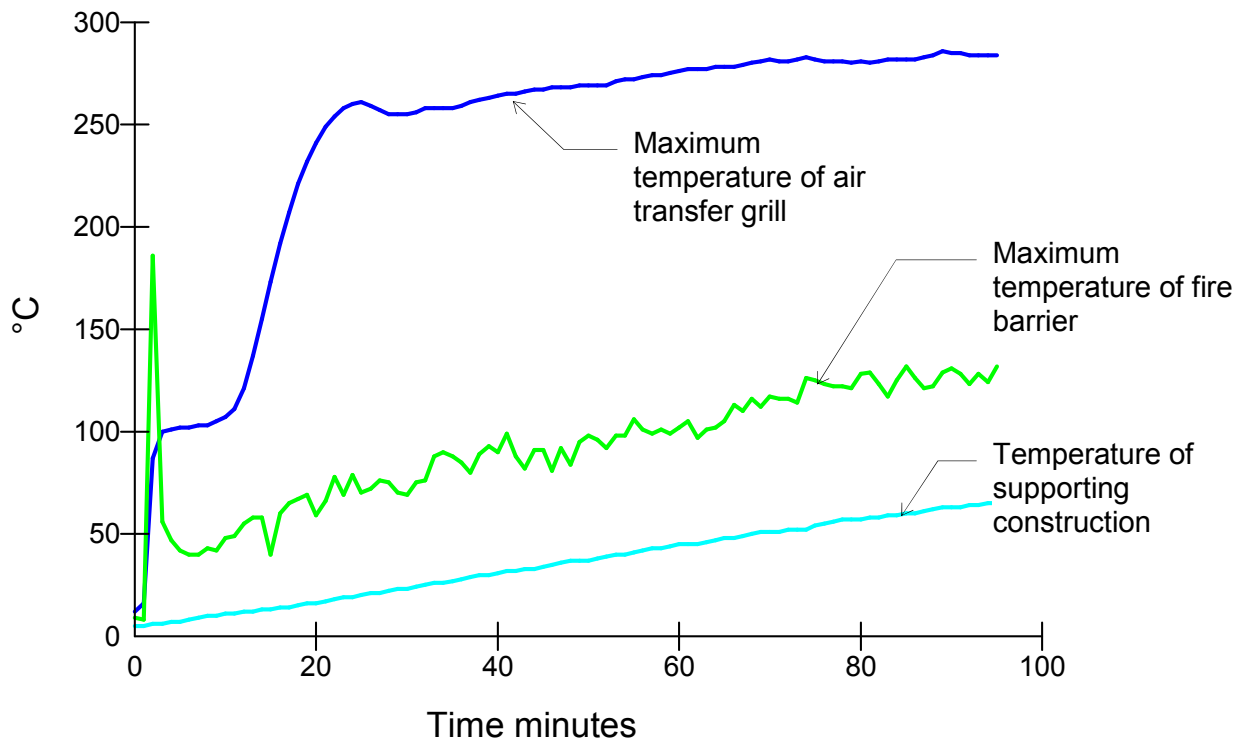
The temperature of the unexposed face was monitored by means of two thermocouples fixed to each air transfer grill, three thermocouples fixed to the fire barrier and one thermocouple fixed to the supporting construction. (see Appendix figure 3).

Integrity			Insulation
	Cotton pad	Gap gauge	Continuous flaming	
Air transfer grill A	95 (ninety five) minutes	95 (ninety five) minutes	95 (ninety five) minutes	15 (fifteen) minutes
Air transfer grill B	95 (ninety five) minutes	95 (ninety five) minutes	95 (ninety five) minutes	7 (seven) minutes

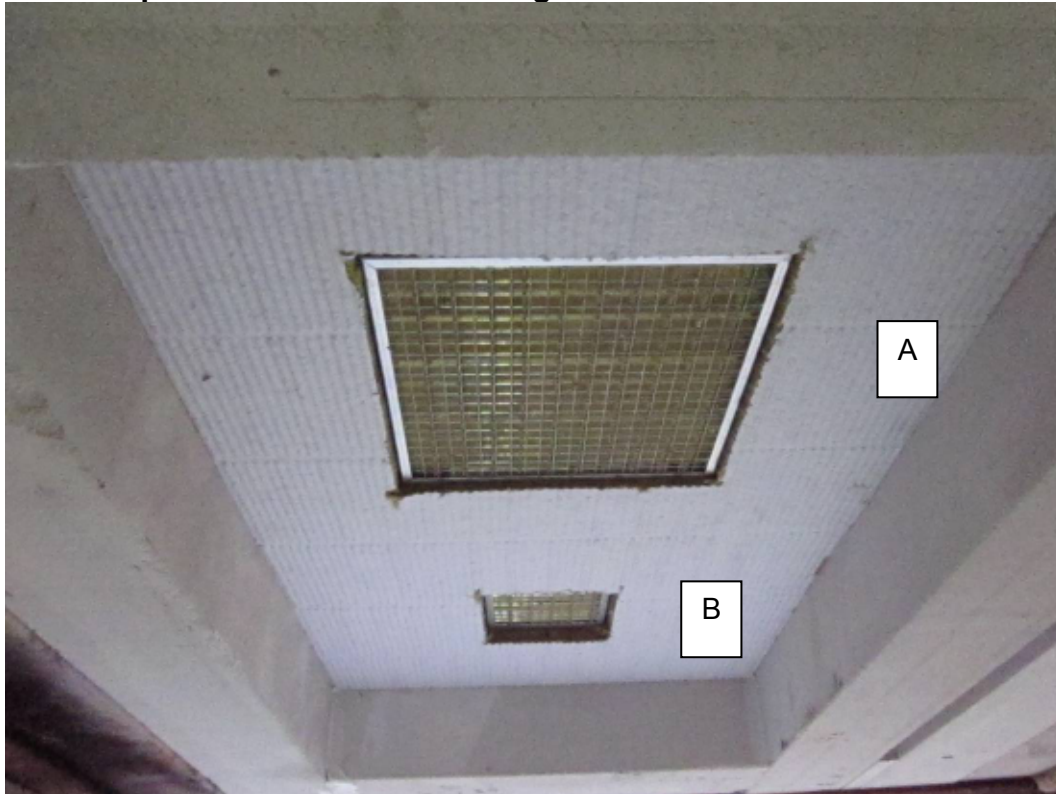
Exposed face of air transfer grills

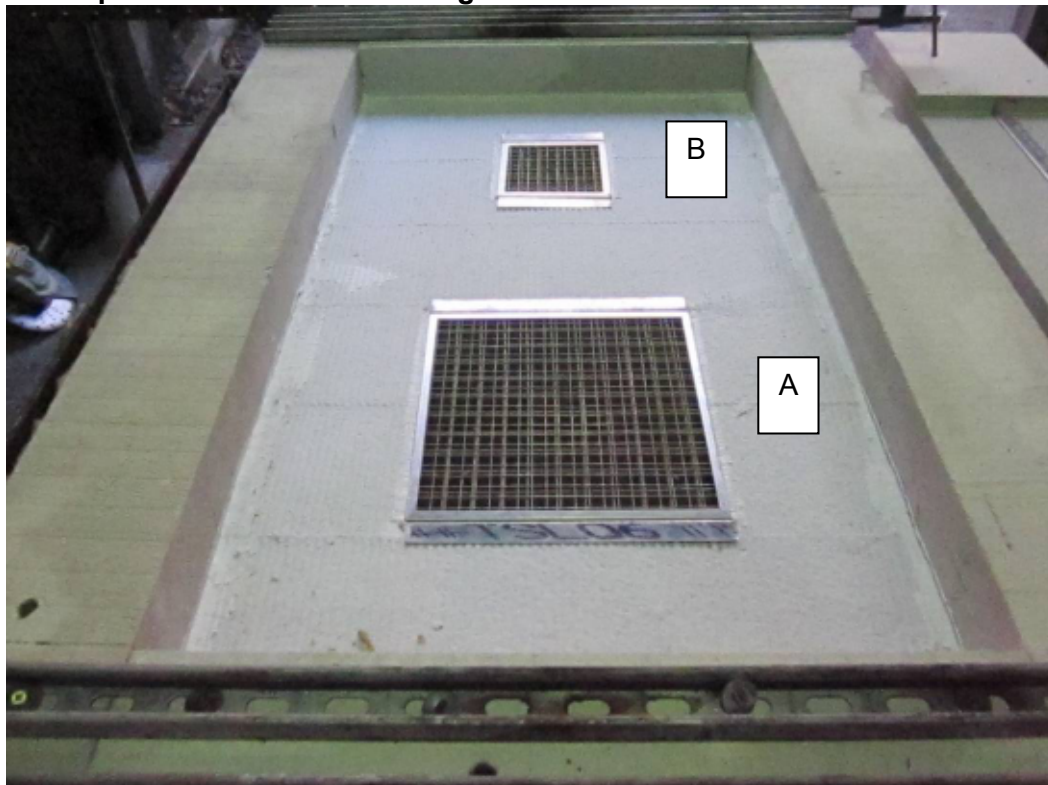
Unexposed face of air transfer grills at start of test

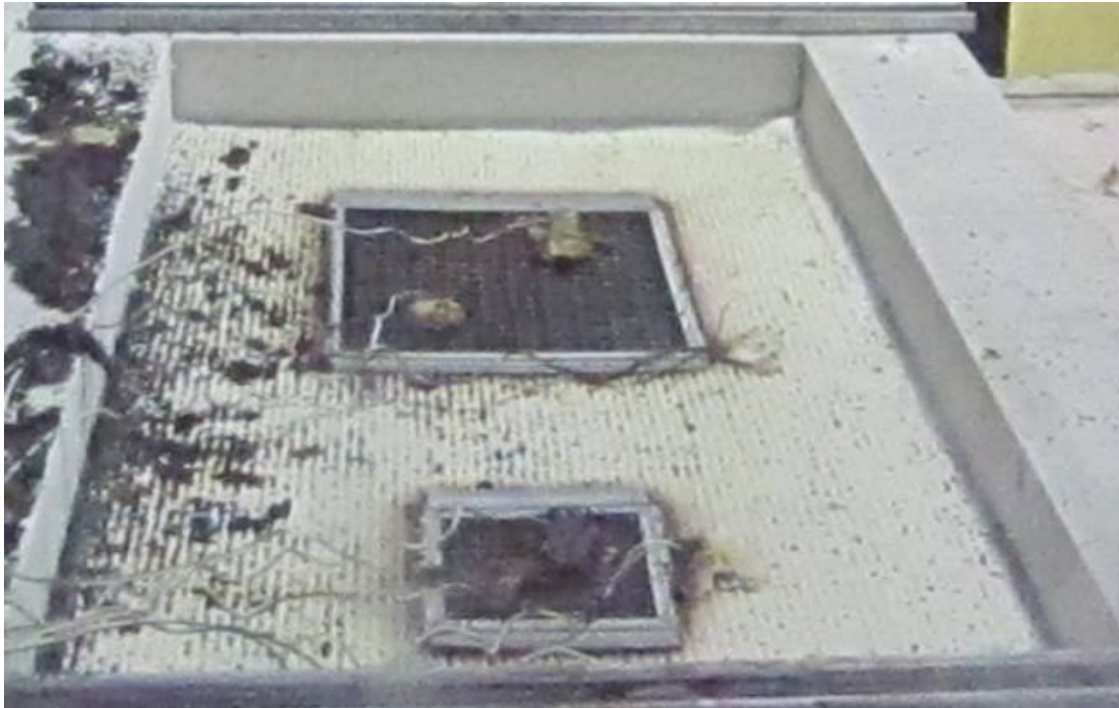
After 90 minutes

Time (minutes)	Comments
0.00	Test started.
01.30	There is smoke issuing from both air transfer grills.
07.00	The intumescent in both air transfer grills has reacted and sealed.
26.00	There is discolouration to the fire barrier batt ablative coating around the perimeter of the air transfer grills.
31.40	Air transfer grill A, a cotton pad integrity test was performed at the centre of the grill, no failure.
32.30	Air transfer grill B, a cotton pad integrity test was performed at the centre of the grill, no failure.
36.00	No change.
60.00	No change.
75.00	There is discolouration to the batt around the perimeter of the fire barrier.
91.30	Air transfer grill A, there is a glow visible from the far right hand corner of the specimen.
95.44	The fire barrier batt has fallen into the furnace, thereby constituting integrity failure .
96.00	Test terminated.

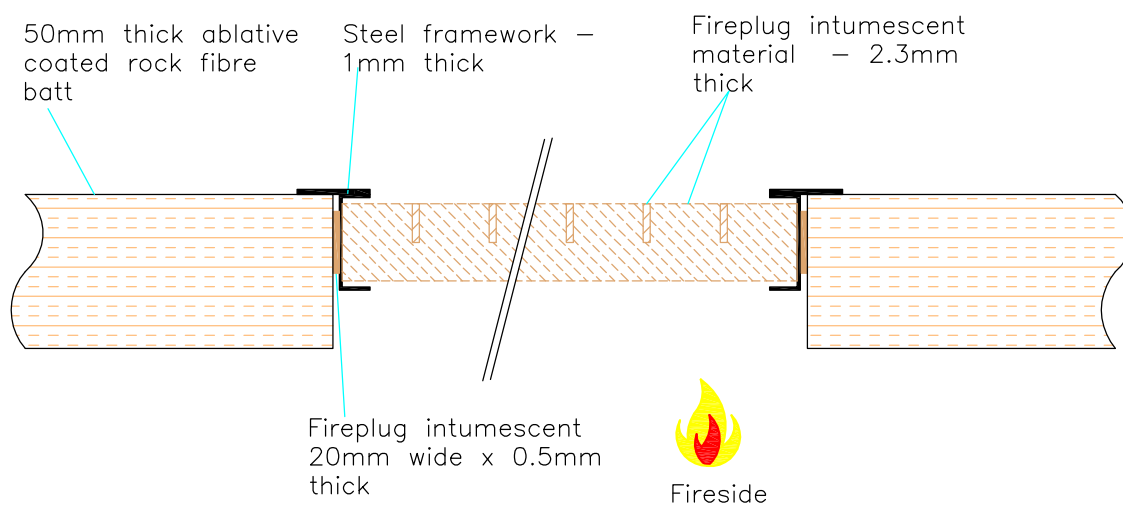
Section A-A

Grille A

Cross section of air transfer
grills and ablative coated batt

Air transfer grill A was referenced Fireplug FPG300 x 300 (intumescent ventilation grill) and measured 290mm wide x 290mm long x 38mm thick. The air transfer grill block comprised a profiled steel 'C' section framework, 1mm thick x 38mm wide with 10mm upstands, supporting Fireplug intumescent material, 2.3mm thick. The intumescent sheet strips were slotted and pressed together at right angles to form an orthogonal grid.

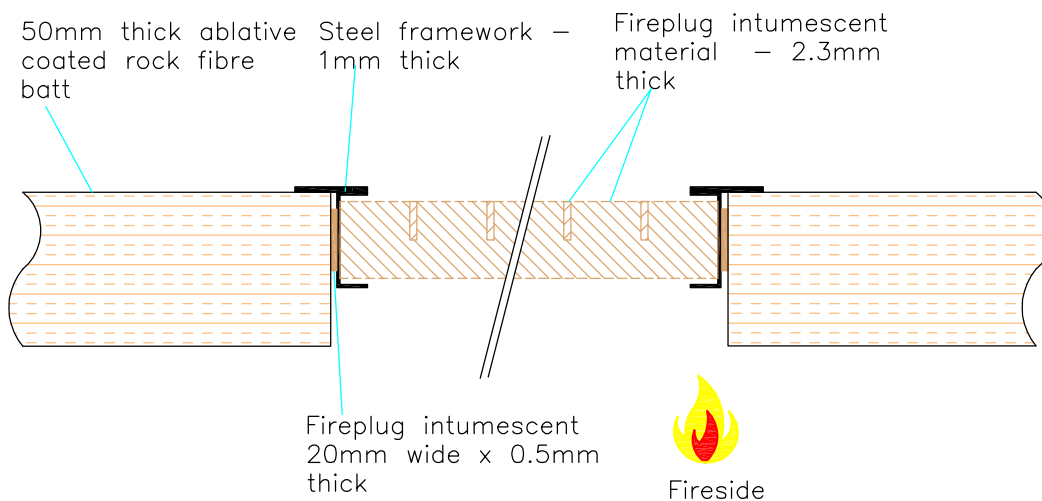
Section B-B

Grille B

Air transfer grill B was referenced Fireplug FPG150 x 150 (intumescent ventilation grill) and measured 150mm wide x 150mm long x 25mm thick. The air transfer grill block comprised a profiled steel 'C' section framework, 1mm thick x 25mm wide with 10mm upstands, supporting Fireplug intumescent material, 2.3mm thick. The intumescent sheet strips were slotted and pressed together at right angles to form an orthogonal grid.

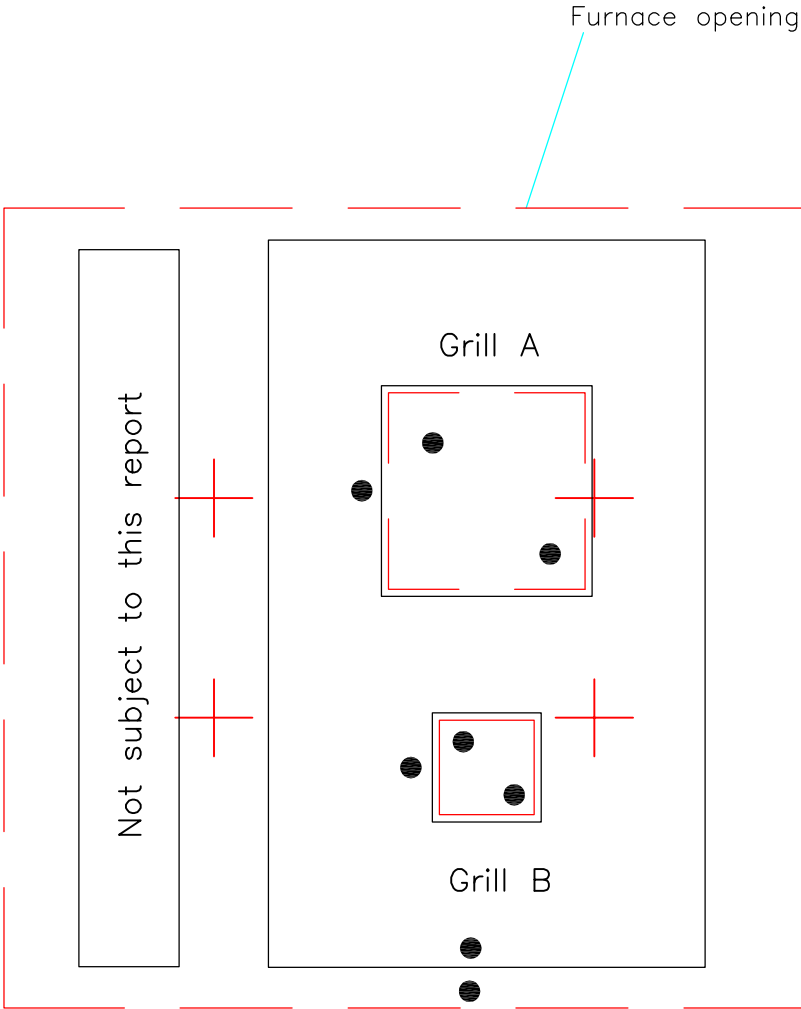
- + : Furnace Thermocouples
- : Unexposed Face Thermocouples

Title
Thermocouple positions
